**NASA TECHNICAL
MEMORANDUM**

NASA TM X-64567

**FIELD TESTS USING DEAD RECKONING AND MONOPTIC VIDEO
FOR REMOTE LUNAR SURFACE NAVIGATION**

By William C. Mastin and Peter H. Broussard, Jr.
Astrionics Laboratory

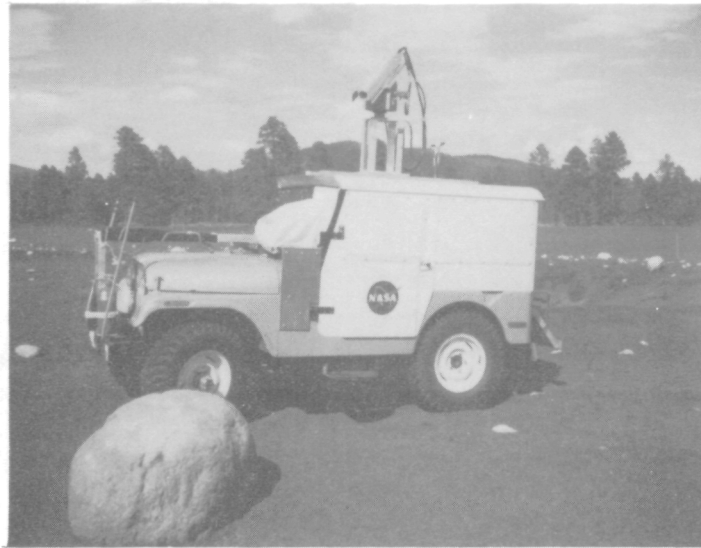
Figure 1. Exterior of Jeep.

less sophisticated setup. Rather than using a remotely controlled vehicle, which can become complex, we decided to use a commercially available four-wheel drive vehicle (the Jeep shown in Figure 1) and a driver. The driver could then operate the TV camera and navigation system and monitor information such as coordinates and pan and tilt angles. Because the average speed of a lunar sortie would be very low, the vehicle windows were enclosed and the driver was provided with a monitor by which he could drive and observe. In this manner, a slow speed was necessarily maintained and, additionally, a great deal was learned about remote driving, as well as navigation.
